SERVICE REPORT

Vessel name: CMA CGM ANDROMEDA

Engine Type: MAN 9L/27/38 Rhrs: 40000

Reason : Planned overhaul

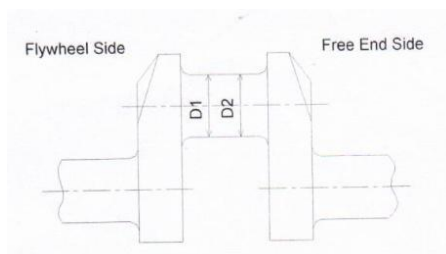
(2). CRANK PIN BEARING JOURNAL MEASURING Ovality limit: 0.03mm

Unit	No 1		No2		No3		No4	
	T-B	P-S	T-B	P-S	T-B	P-S	T-B	P-S
D1	249.97	249.96	249.96	249.96	249.97	249.97	249.97	249.97
D2	249.97	249.97	249.96	249.96	249.97	249.98	249.97	249.97
Ovality	0.01		0.00		0.01		0.00	
Unit	No 5		No6		No7		No8	
	T-B	P-S	T-B	P-S	T-B	P-S	T-B	P-S
D1	249.97	249.97	249.97	249.98	249.97	249.96	249.97	249.97
D2	249.97	249.98	249.97	249.97	249.97	249.97	249.97	249.97
Ovality	0.01		0.01		0.01		0.00

Unit	No 9	
	T-B	P-S
D1	249.96	249.97
D2	249.96	249.97
Ovality	0.01

Remark: No abnormal found

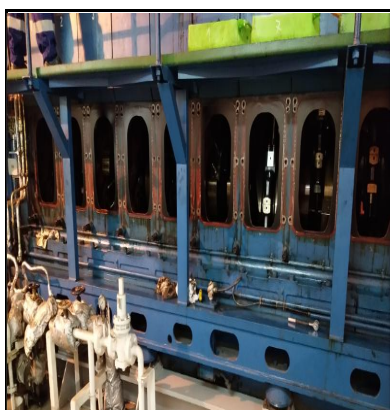
Opened both doors

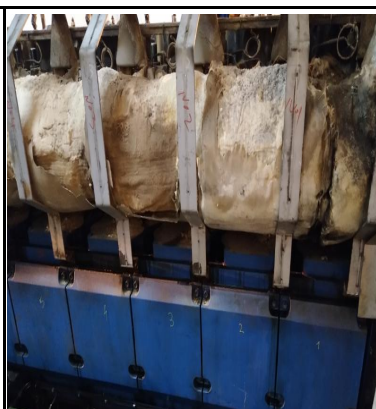
Removed covers

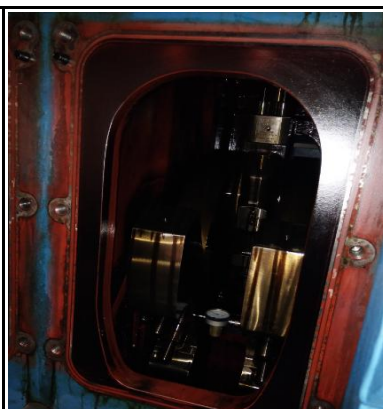
Crankshaft deflection before

position	NO.1	NO.2	NO.3	NO.4	NO.5	NO.6	NO.7	NO.8	NO.9
AFT BDC(X)	0	0	0	0	0	0	0	0	0
STB (P)	-1	3	-0.5	-0.5	-1	-0.5	-1	2	4
TD C (T)	-2	2	-2	-1	0	-2	-2	3	8
PS (S)	-1	-1	-2	1	1	1	2.5	3	4
B4BDC (Y)	0	0	-3	2	2	0.5	1	2	-1
$B=1/2*(X+Y)$	0	0	-1.5	1	1	0.25	0.5	1	-0.5
$V= T-B$	-2	2	-0.5	-2	-1	-2.25	-2.5	2	8.5
$H= P-S$	0	4	1.5	-1.5	-2	-1.5	-3.5	-1	0
$D= P+S$	-2	2	-2.5	0.5	0	0.5	1.5	5	8
$C=T+B$	-2	2	-3.5	0	1	-1.75	-1.5	4	7.5

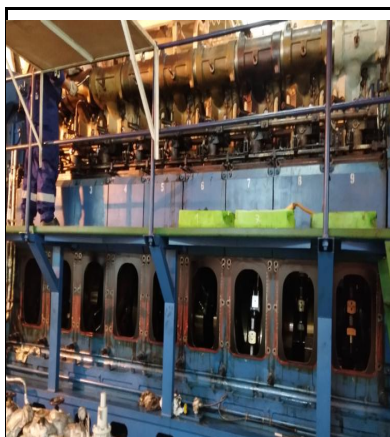
Removed all attachments

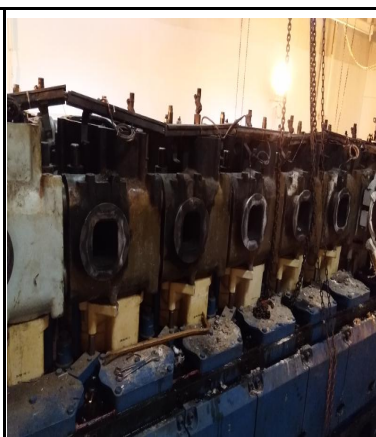
Removed exhaust pipes

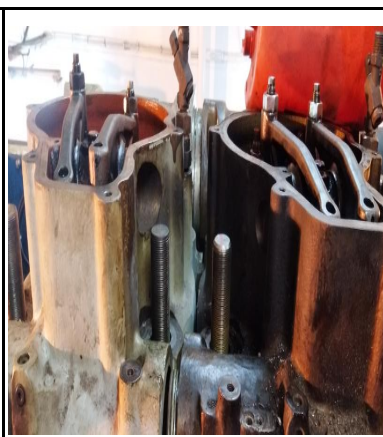
Loose nuts of cylinder heads

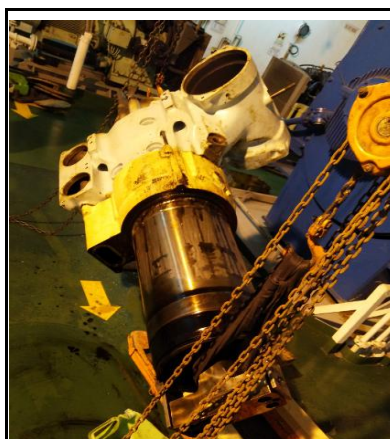
Lift up cylinder units

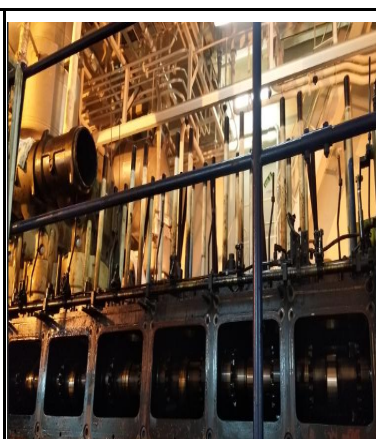
Lifted all cylinder units

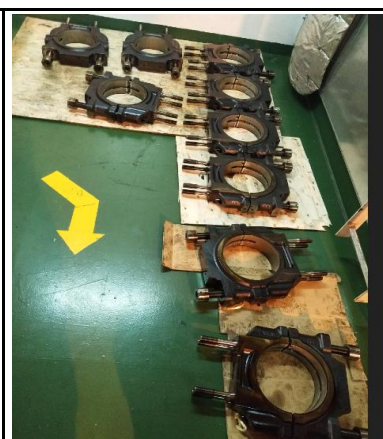
Took out all marine heads

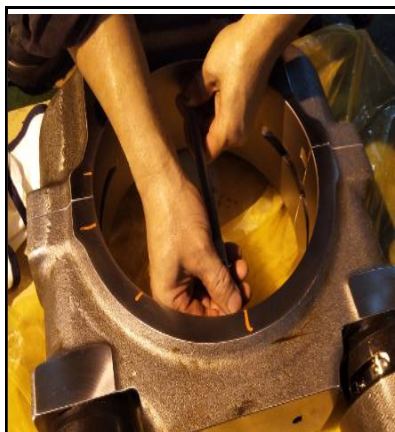
Measured marine heads

A	B	C	D	E	Ovality
Unit No. 1	0.04	0.01	0.04	0.03	0.01	0.03
Unit No. 2	0.04	0.01	0.02	0.02	0.01	0.03
Unit No. 3	0.04	0.02	0.04	0.04	0.01	0.03
Unit No. 4	0.05	0.02	0.05	0.06	0.02	0.04
Unit No. 5	0.05	0.02	0.05	0.05	0.02	0.03
Unit No. 6	0.05	0.03	0.04	0.05	0.02	0.03
Unit No. 7	0.05	0.02	0.04	0.04	0.02	0.03
Unit No. 8	0.05	0.01	0.02	0.04	0.02	0.04
Unit No. 9	0.03	0.05	0.04	0.04	0.00	0.05

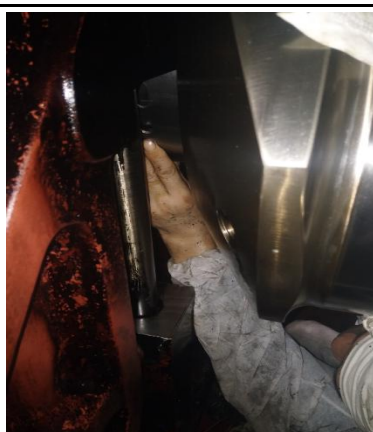
Carried out main bearings changed

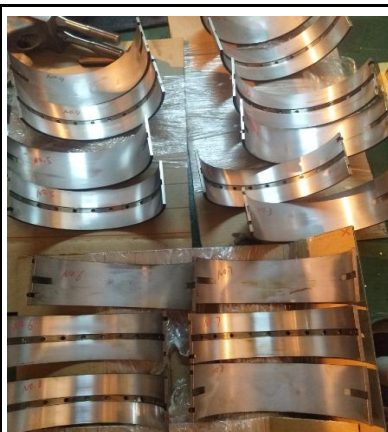
All main bearings changed

Remark: All main bearings shell were replaced by new ones

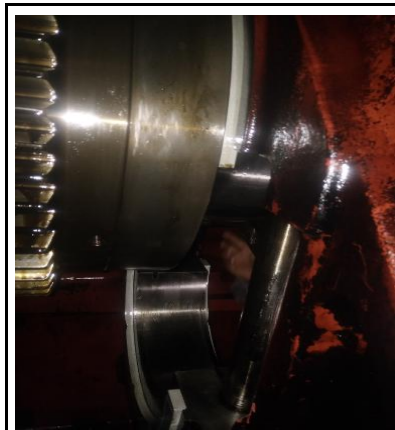
Thrust bearings changed

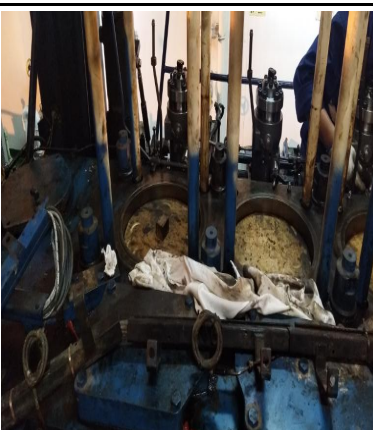
Cleaned each cylinder

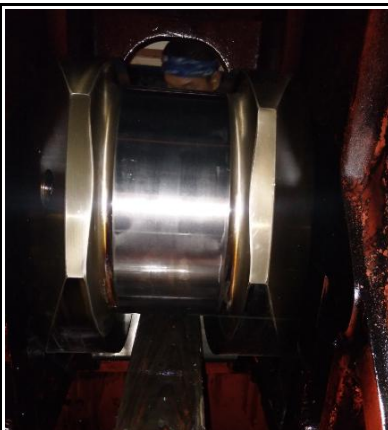
Check crankpin journal

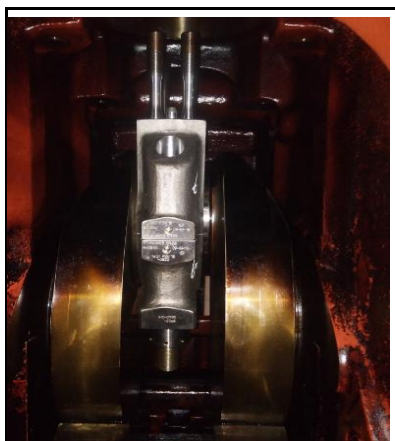
Installed spare marine heads

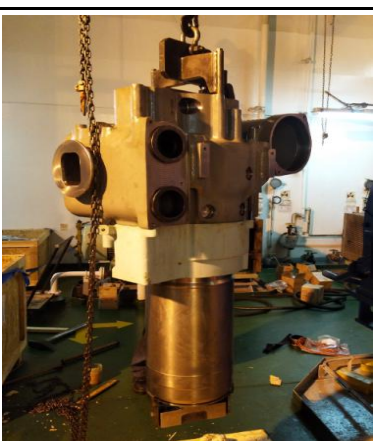
Put back recondition cylinder unit

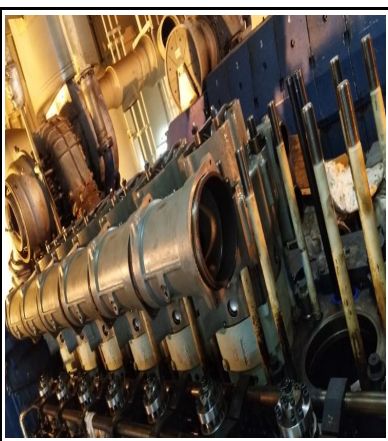
cylinders units on engine block

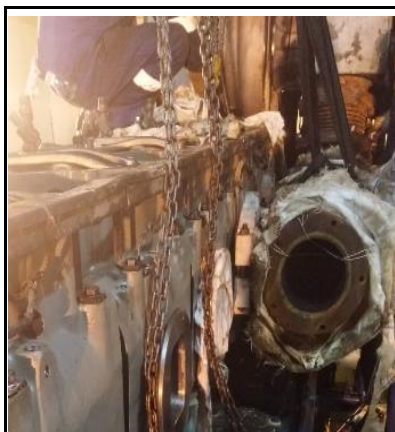
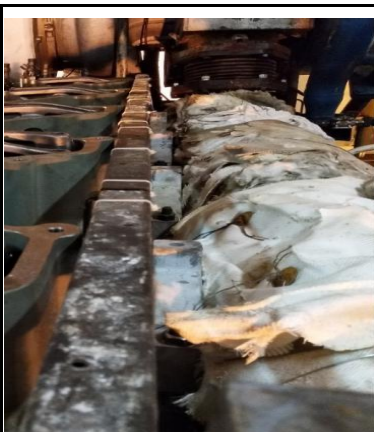
Put back exhaust pipes

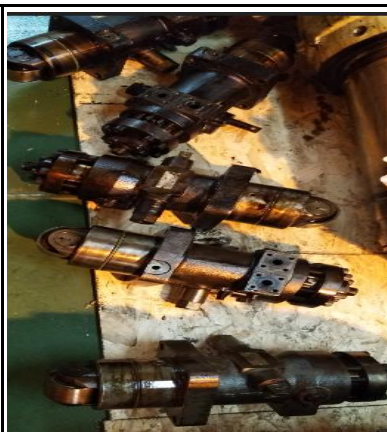
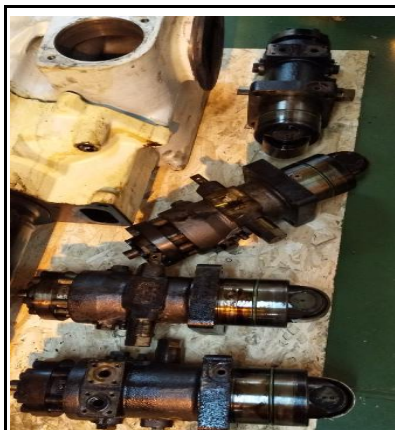
Removed fuel pumps

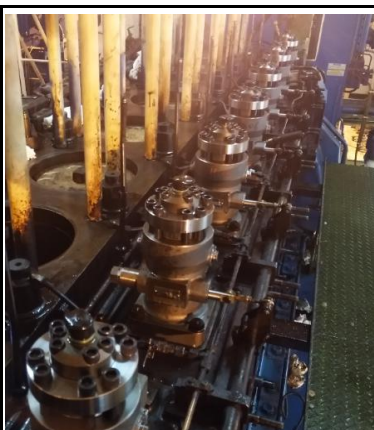
Put all new pumps

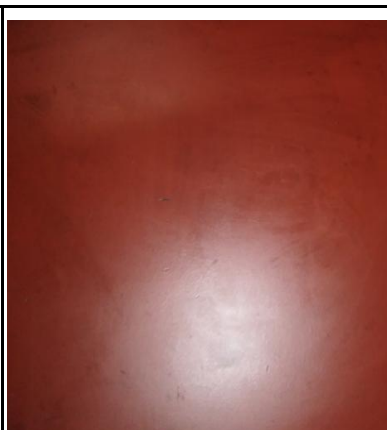
Cleaned sump tank

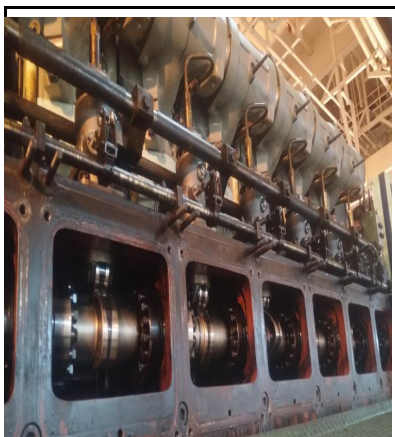
Camshaft checking

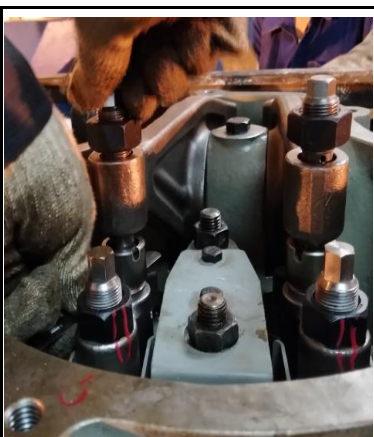
Check v/v clearance

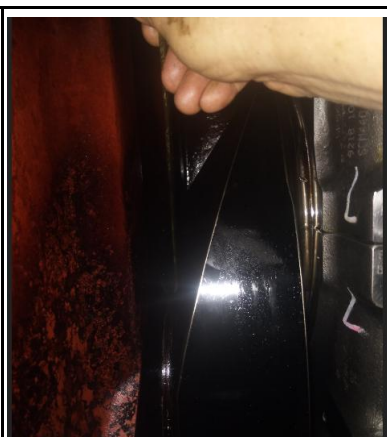
Check main bearings clearance

NO.	FWD(P)	FWD(MID)	FWD(S)	AFT(P)	AFT(MID)	AFT(S)
1	0.15	0.20	0.15	0.16	0.21	0.15
2	0.16	0.21	0.16	0.15	0.20	0.15
3	0.15	0.2	0.15	0.15	0.20	0.15
4	0.16	0.21	0.16	0.15	0.19	0.16
5	0.15	0.19	0.15	0.16	0.19	0.16
6	0.15	0.2	0.15	0.15	0.20	0.20
7	0.16	0.20	0.16	0.15	0.20	0.15
8	0.15	0.20	0.15	0.15	0.20	0.15
9	0.16	0.21	0.16	0.16	0.20	0.16
10	0.15	0.20	0.15	0.15	0.20	0.15
11	0.15	0.20	0.15	0.15	0.20	0.20

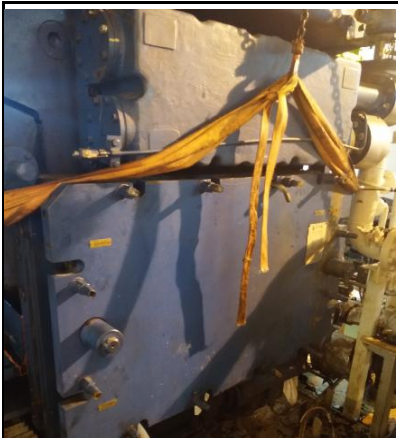
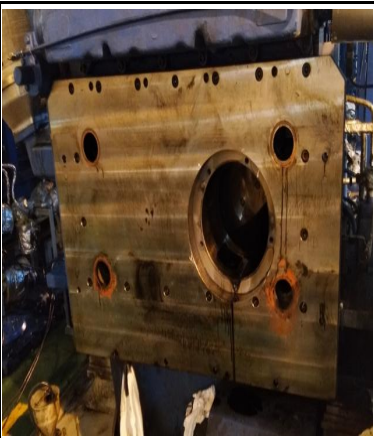
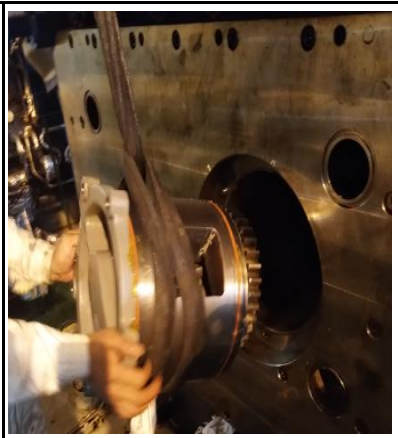
Removed out FW Cooler	Took out H.T.C.W PUMP	Installed new complete one

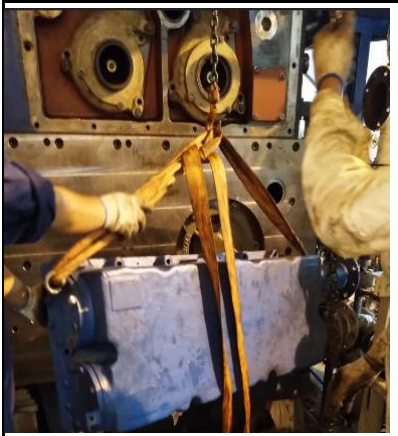
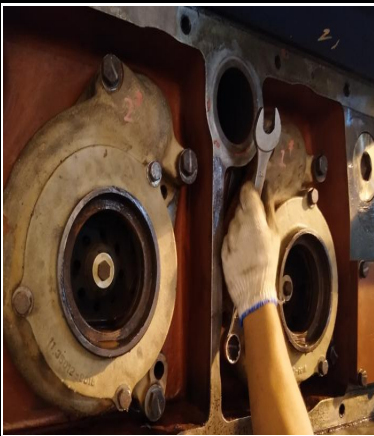
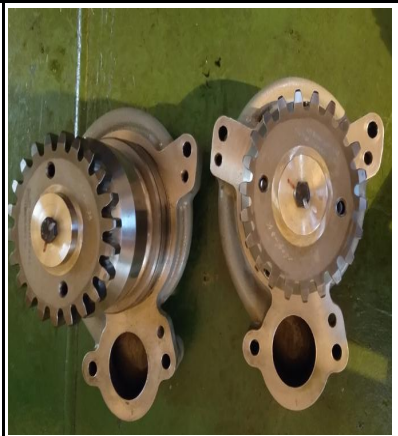
Removed out L.O. cooler	Took out L.O. pumps	New pumps

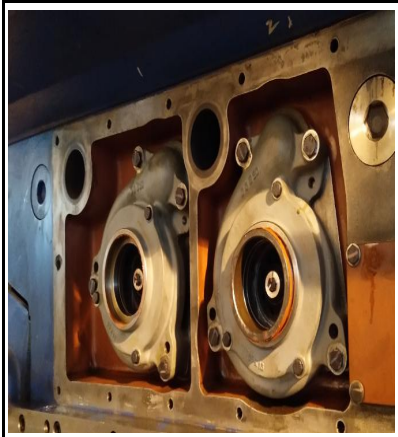
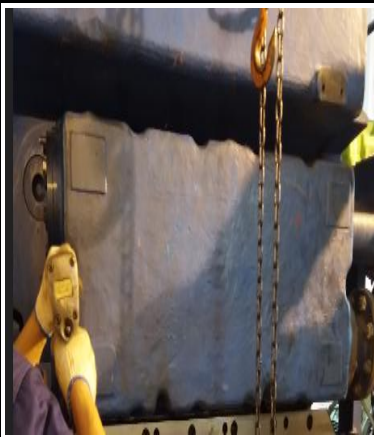
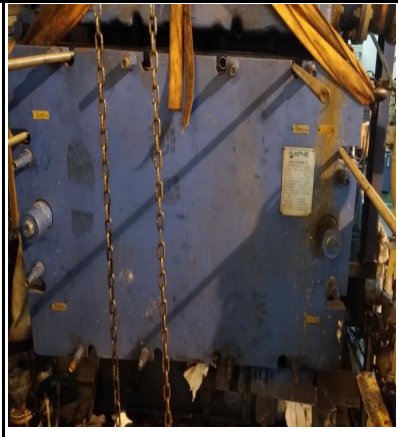
Installed new pumps	Installed L.O. Cooler	Installed F.W. Cooler
